**EFFECT OF ENVIRONMENT ON CREEP BEHAVIOR OF AN OXIDE/OXIDE
CFCC WITH $\pm 45^\circ$ FIBER ORIENTATION**

THESIS

AFIT/GAE/ENY/06-J15

AIR FORCE INSTITUTE OF TECHNOLOGY

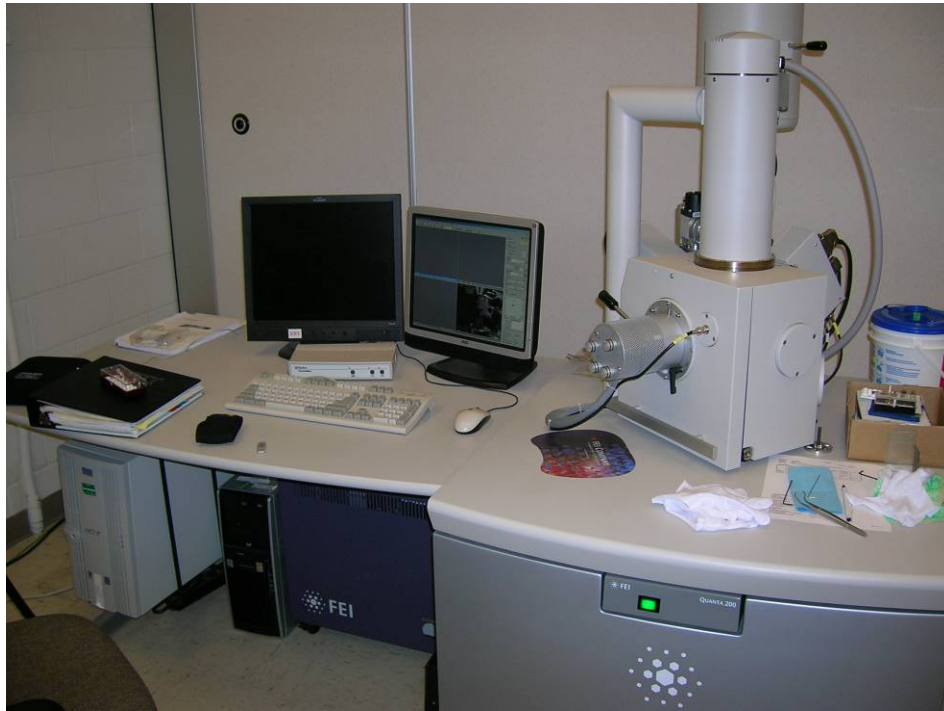
Figure 25. FEI FP 2011/11 Quanta 200 HV scanning electron microscope.

scanning electron microscopy (ESEM) mode. In the ESEM mode water vapor is present within the vacuum chamber enabling the non-conductive samples to become conductive. For observations at higher magnification, samples were coated with carbon paint using the SPI Module Carbon Coater. In addition, the SEM included an EDAX Genesis 4000 Energy Dispersive X-Ray Spectroscopy (EDS) system. This system permitted a detailed examination of fractured surfaces in order to determine what elements were present.
